6
National Dam Safety Program.
High Bridge Dam, Susquehanna River Basin,
Commonwealth of Pennsylvania,
Schuylkill County (NDS-PA-679).
Phase I Inspection Report.

HIGH BRIDGE DAM

PHASE I INSPECTION REPORT

11
SEPTEMBER 1978

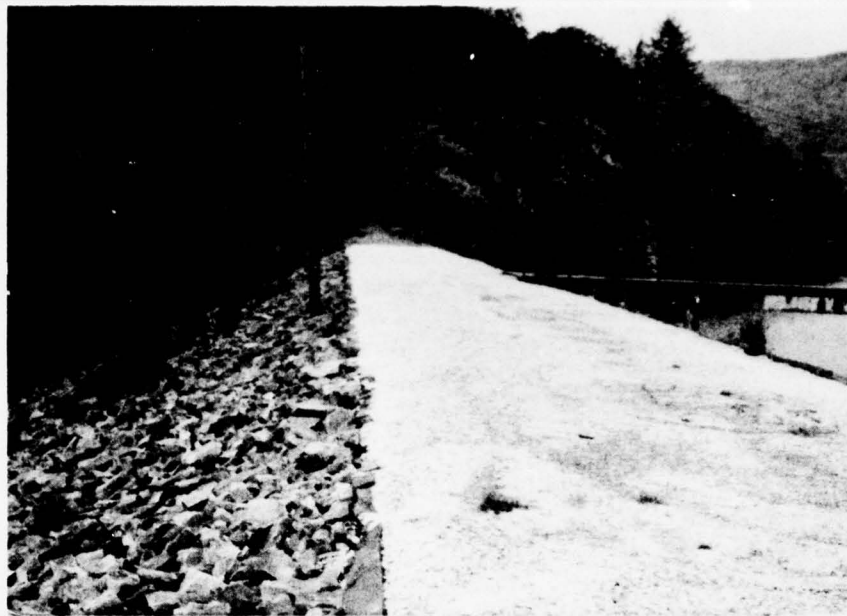
Dam Crest

The dam embankment is in good condition. The downstream slope cover is dumped rock with some sparse weed growth. This vegetation is removed each October at the end of the normal weed growing season. The upstream slope cover is also dumped rock. Neither of the slopes showed any signs of distress. The top of the embankment has a 3/4 inch size stone surface. This area is also in good condition.

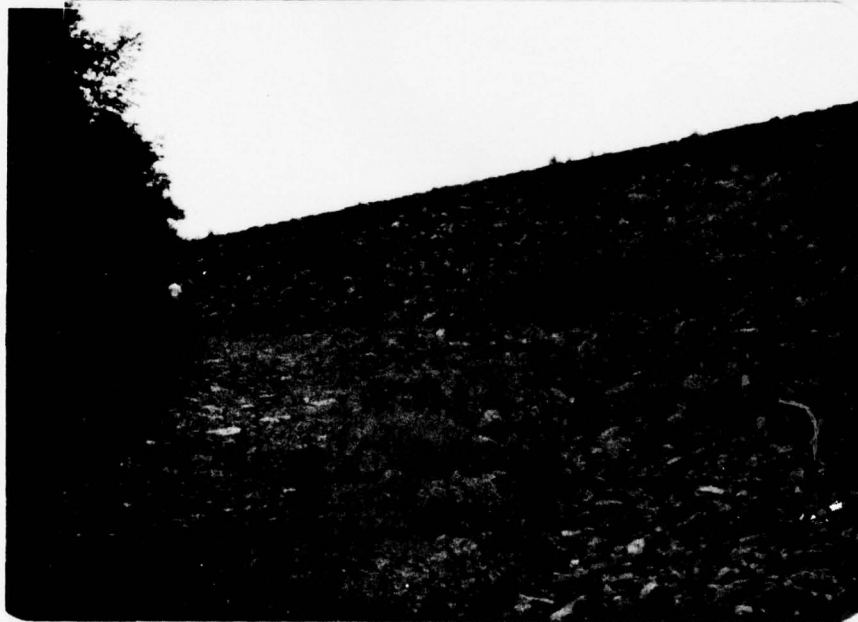
Downstream
Slope

The visual inspection of the embankment did not detect any signs of distress that would indicate an unstable condition. Settlement, sloughage or misalignment were not observed at any location.

1. That careful inspection of the downstream embankment slope be made at the time of the annual slope maintenance and during periods of high pool levels to detect any signs of seepage or slope distress. If such signs are observed, a detailed evaluation of the embankment seepage control should be made.
2. That the cracks and deteriorated areas of the spillway outlet channel walls be repaired in the next maintenance period.
3. That a formal surveillance and downstream warning system be developed to be used during periods of intense or prolonged rainfall.

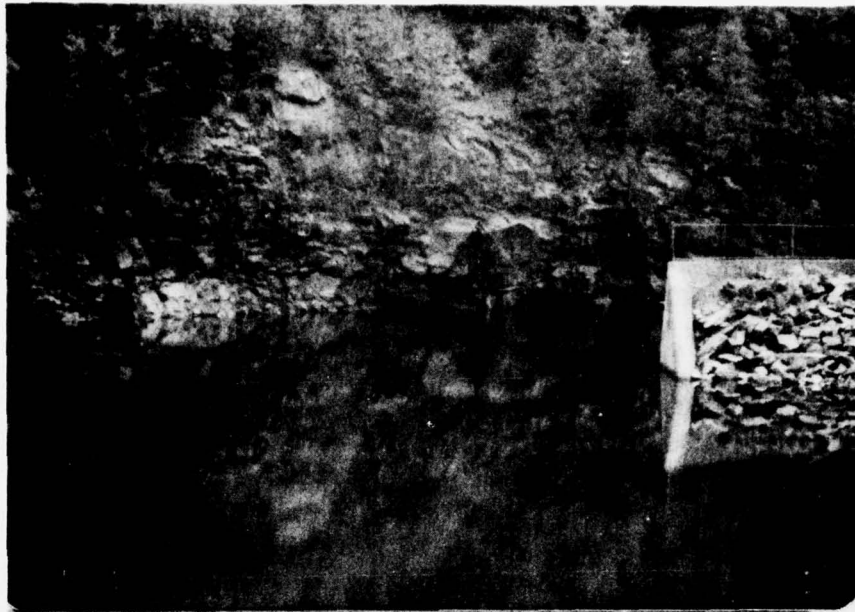
Forebay

The approach channel to the spillway abuts and is excavated into the natural rock formation. It appears to be in sound condition. The right side of the channel is formed by the concrete spillway wall and also is in good condition. The forebay is a curved approach to the spillway. Refer to Appendix D, Plate VII.

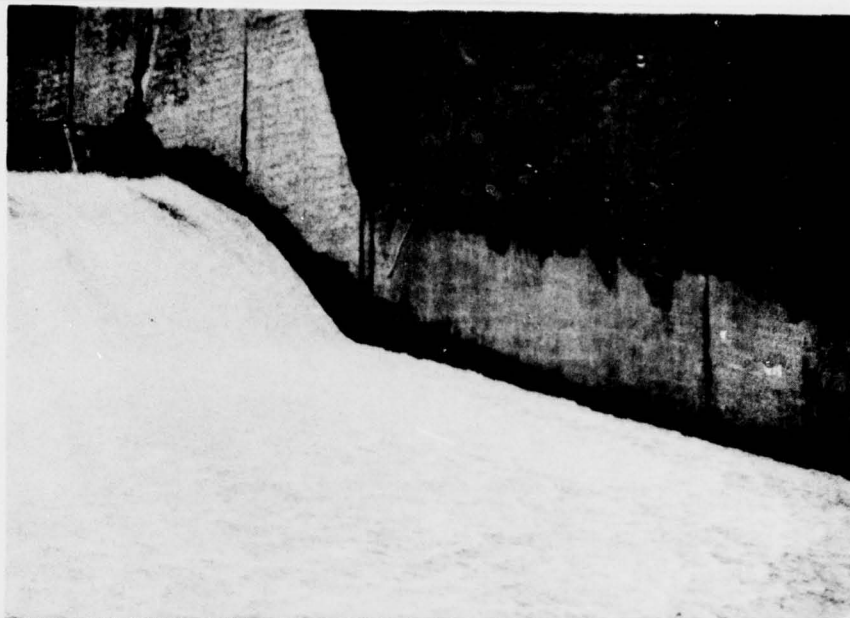
Spillway
Chute

The spillway outlet chute is a concrete channel with vertical walls. Considerable cracking and deterioration of the walls was noted. The channel leads to the stilling basin downstream beyond which the discharge returns to the natural stream channel. Refer to Appendix D, Plate VII.

There were no visual signs of structural instability in the spillway area, the intake tower or the spillway outlet channel. Although some deterioration and slight cracking of the channel walls were noticed, they will not have an influence on the stability of the units at the present time. Regular maintenance can take care of these conditions.

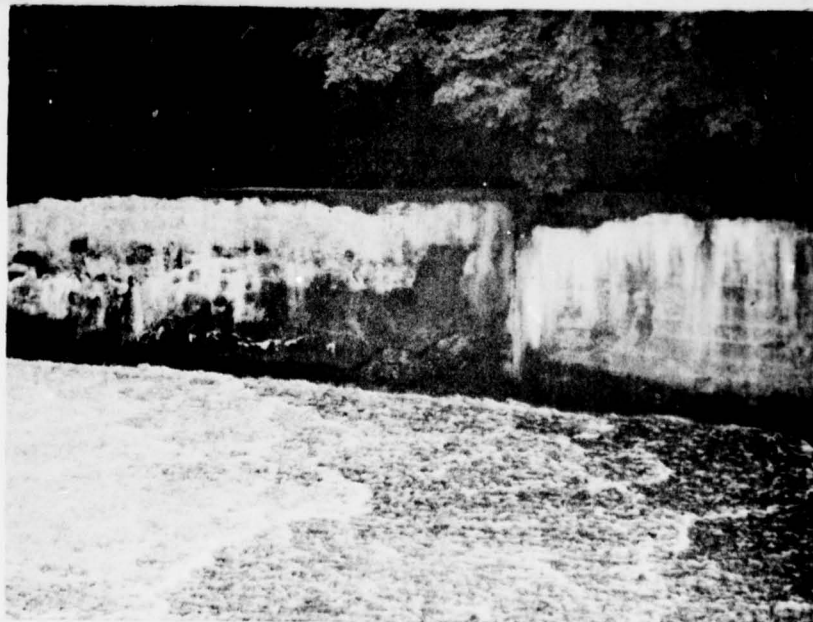
Walls of
Spillway

C. DISCHARGE CHANNEL Lining Cracks Stilling Basin	Concrete channel with vertical walls Considerable cracking and deterioration of walls. Stilling basin curved at downstream end.

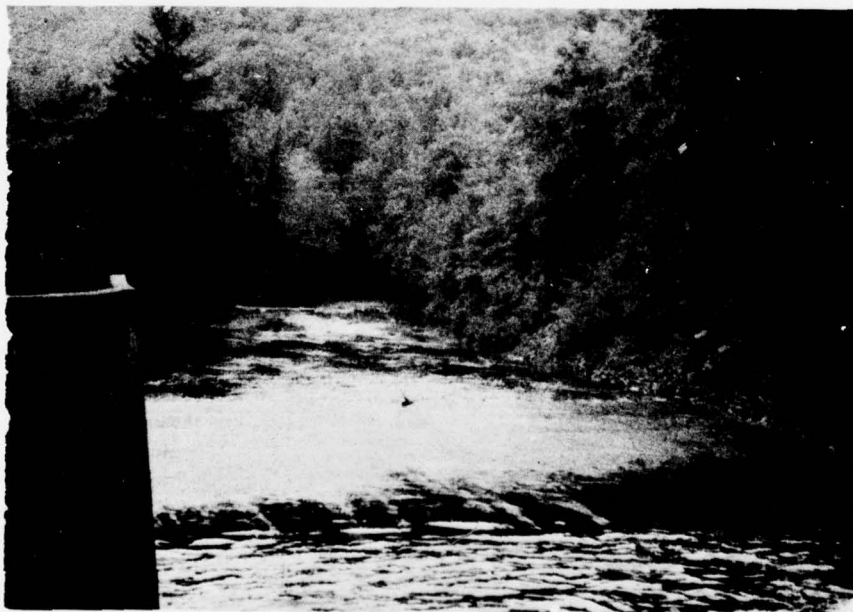
Downstream Channel

The downstream channel is a natural stream with trees and underbrush forming the overbank areas. The slopes are described as woody and rocky. Approximately nine permanent residences are located between the dam and Swatara Creek about two miles downstream. Approximately 30 to 40 persons live in this area. The hazard category, on the basis of these facts is "High".
